**HIGH IMPACT SHOCK TESTS ON TOGGLE
SWITCHES - REED SWITCH CALIBRA-
TION, EXHIBITOR - NSMB67-017**

Evaluation Report No. " ETL-2084

Report of Tests

Toggle Switches

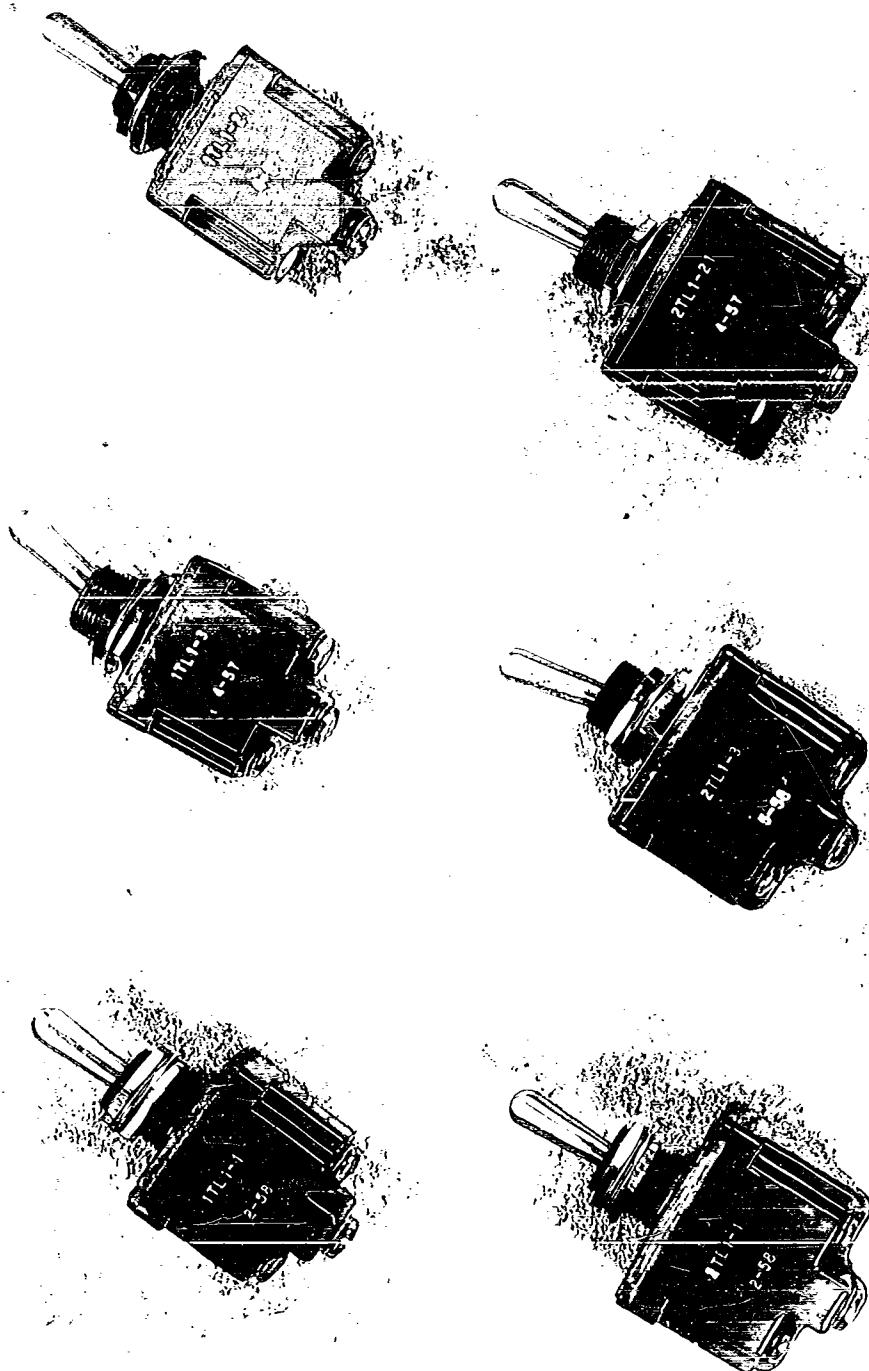
ENCLOSURE (1)

VIEW OF MICRO SWITCH CORPORATION TOGGLE SWITCHES AS RECEIVED FOR SHOCK RESISTANCE EVALUATION

ITL1-1 ITL1-2
ITL1-3 ZTL1-1
ZTL1-2 ZTL1-3

Photographs, enclosures (1) thru (4), illustrate one sample of each of the twenty types of switches received for tests.

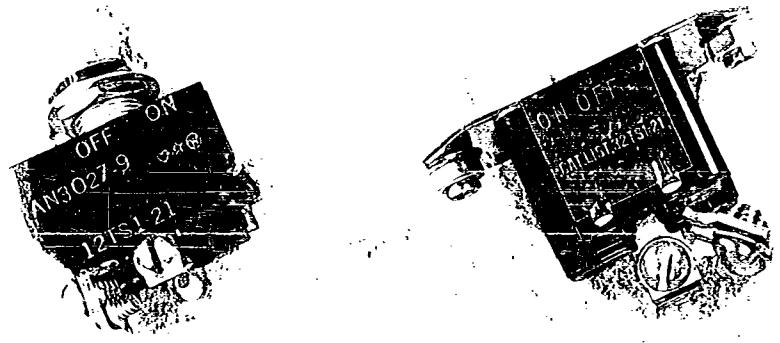
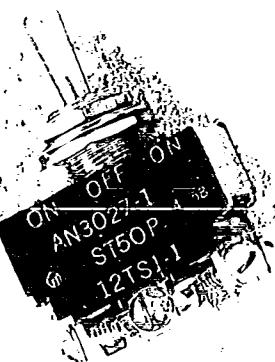
L2TS1-1
37TS1-1

Oscillograms were taken of each impact, but to eliminate including 180 such oscillograms in the report, only typical shots are included, covering at least one impact on each type of switch. The remaining oscillograms are on file in the laboratory and will be forwarded on request. Photograph, enclosure (6), indicates typical failures occurring on the switch samples.

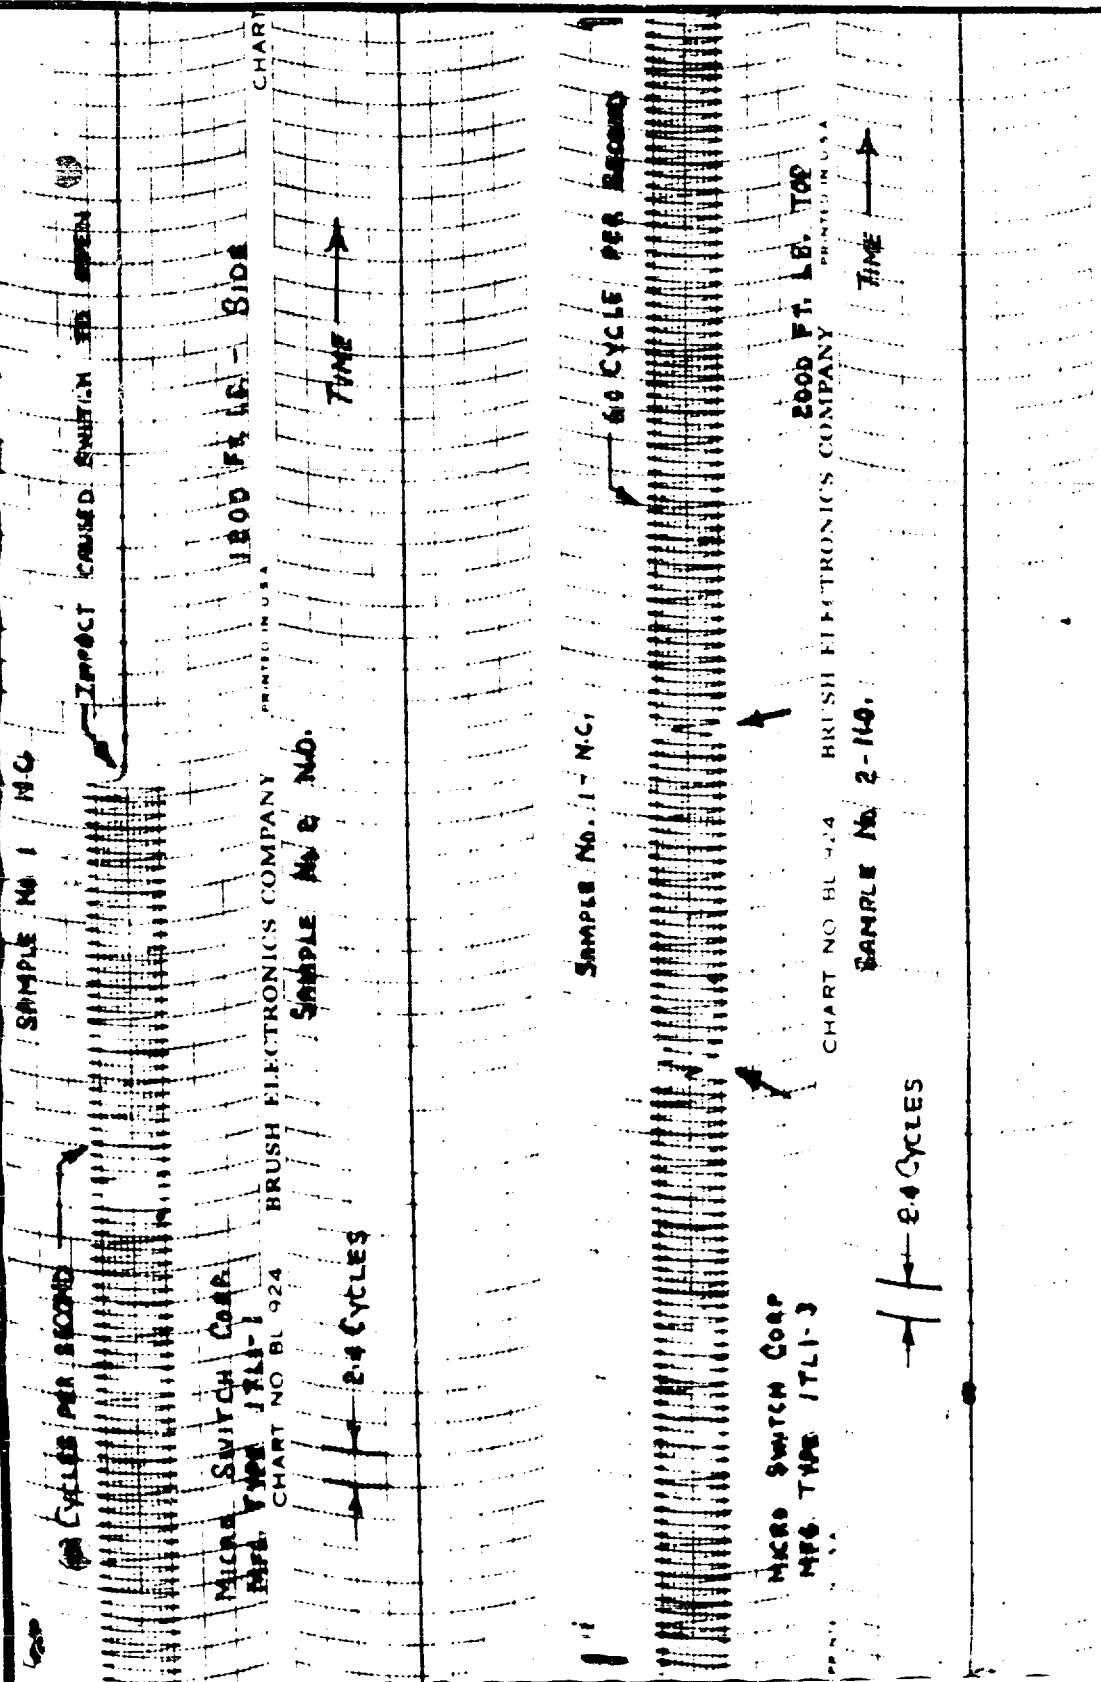
ENCLOSURE 65

Oscillograms showing contact opening or transfer

SAMPLE NO. 1 - N.C.

IMPACT CAUSED SWITCH TO OPEN

MICRO SWITCH Corp.
MFG. TYPE ITL-21

SAMPLE NO. 2 - N.O.

BOTH SAMPLES BECAME DISASSEMBLED DURING IMPACT.

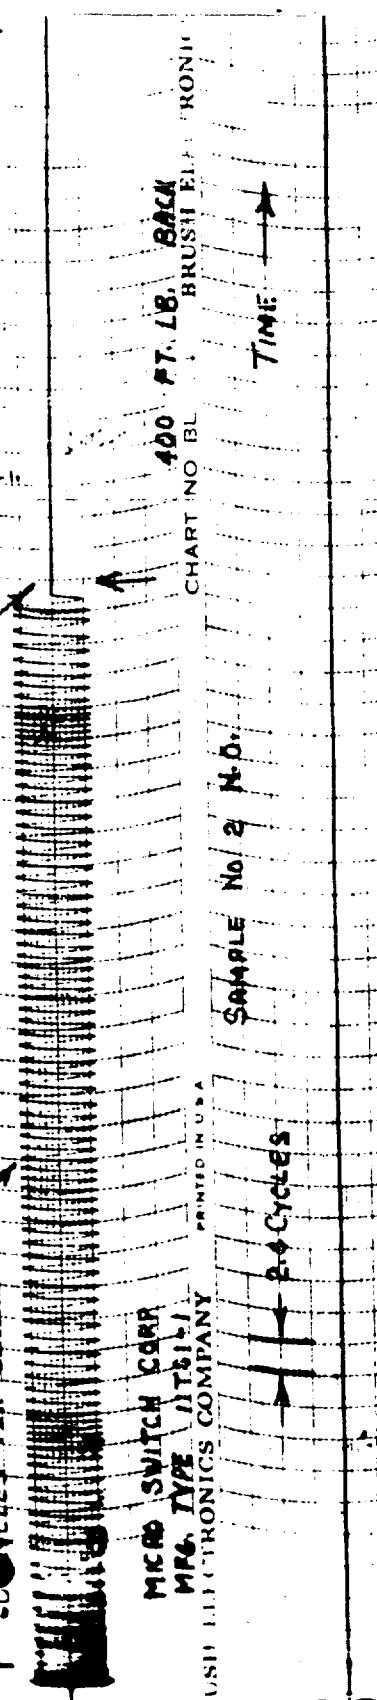
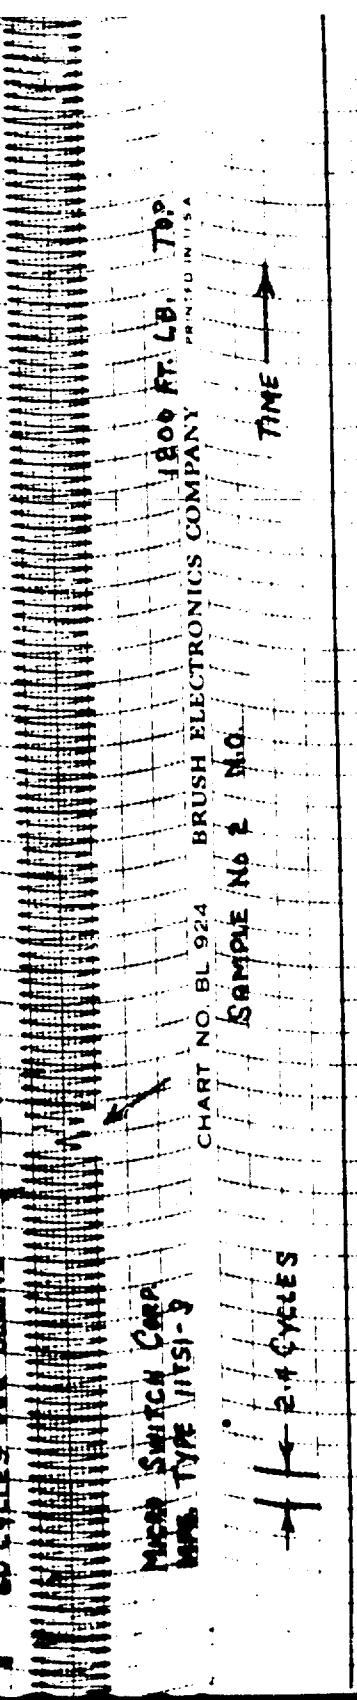
ENCLOSURE (5)
SHEET 3

Oscillograms showing contact opening or transfer

SAMPLE No. 1 INC.

SAMPLE No. 2 INC.

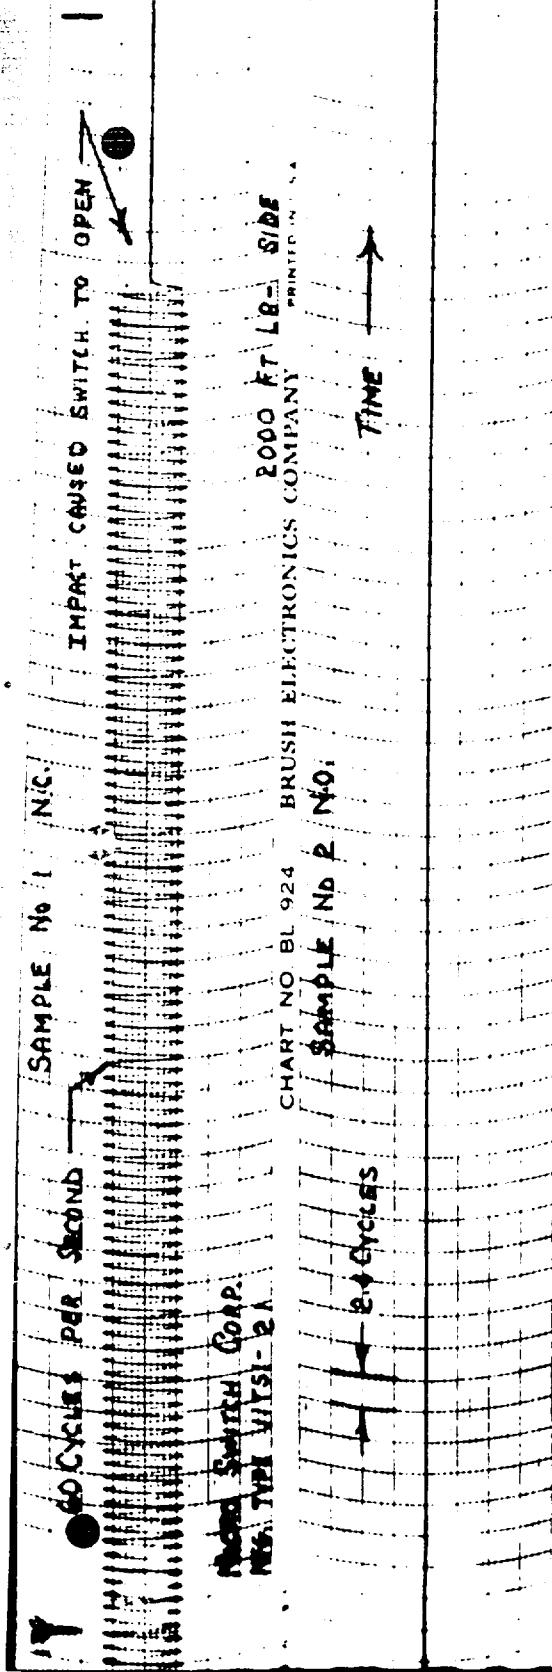
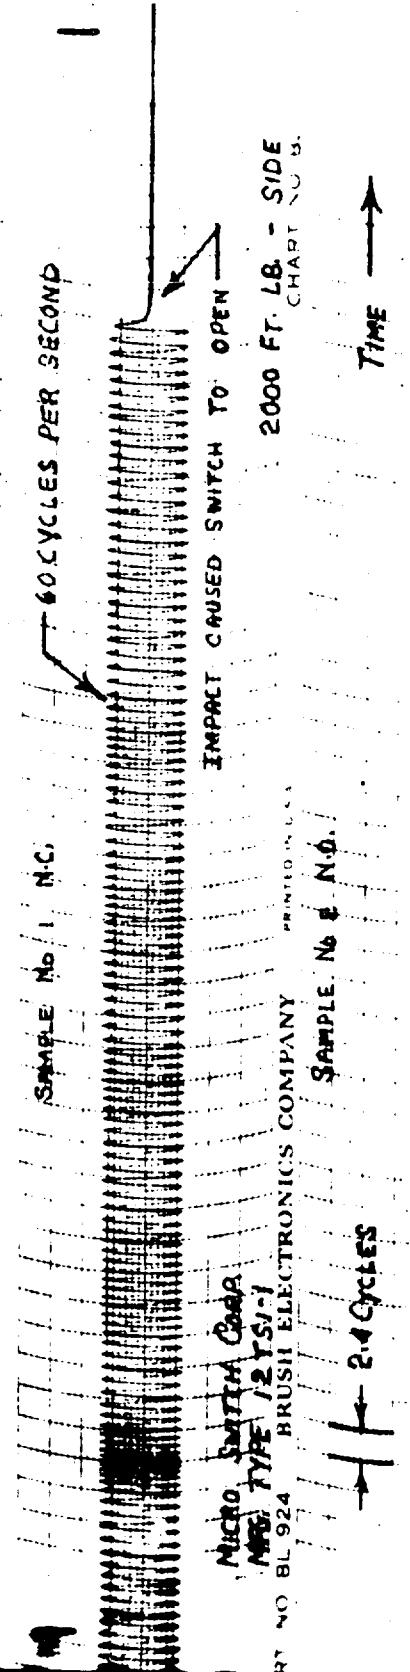
ENCLOSURE (5)
SHEET 4

Oscillograms showing contact opening or transfer

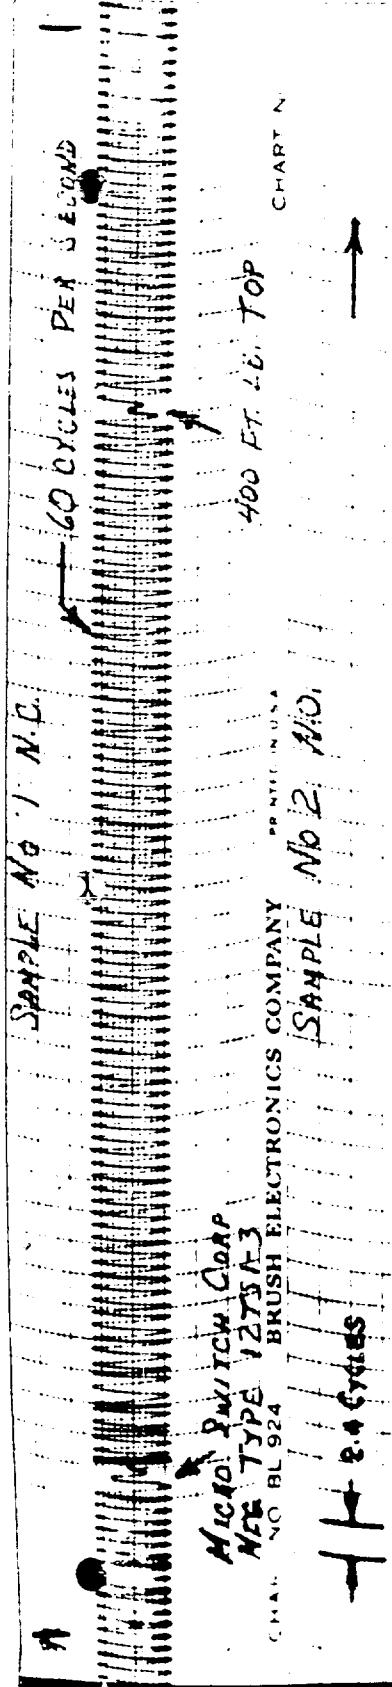
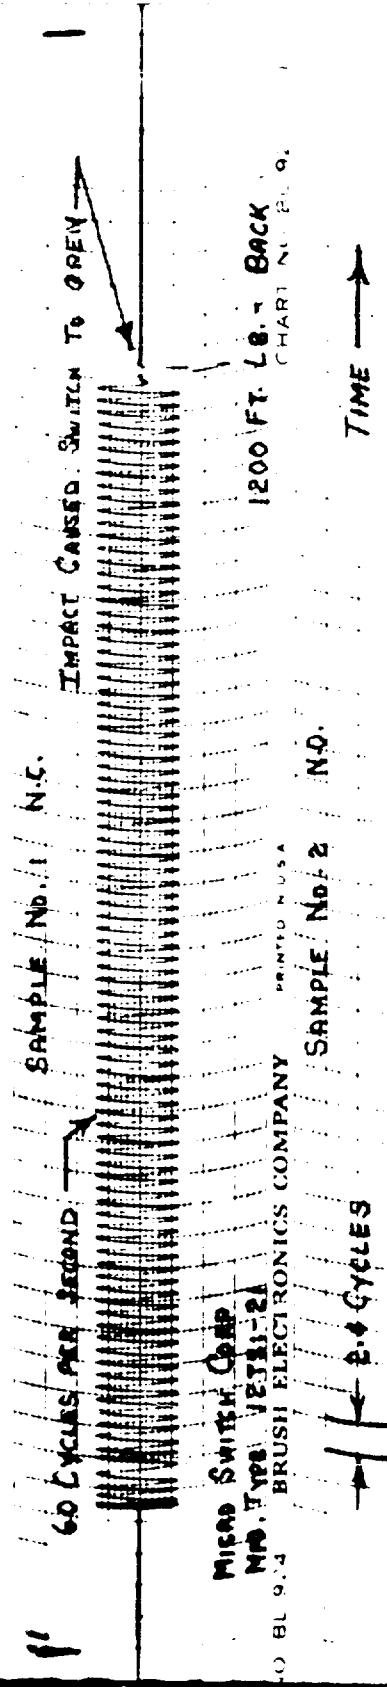
ENCLOSURE (5)
SHEET 5

Oscilloscopes showing contact opening or transfer
TEST No 2994
NSM 687-C17

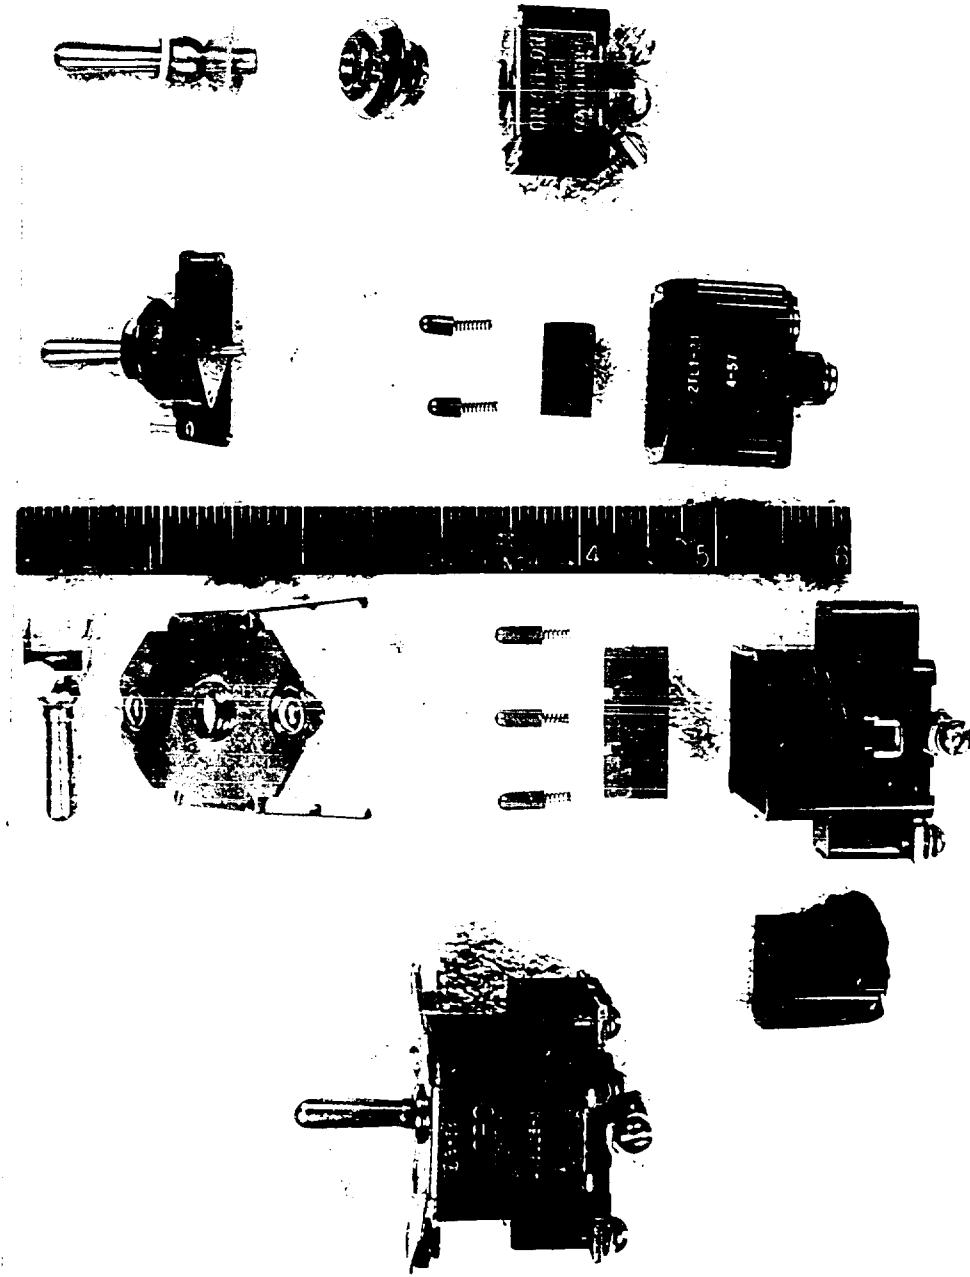
100-25-50 - 314
TYPICAL EXAMPLES OF IMAGE MICRO SWITCH CORPORATION TOGGLE SWITCHES AS A RESULT OF HIGH IMPACT SHOCK TEST
